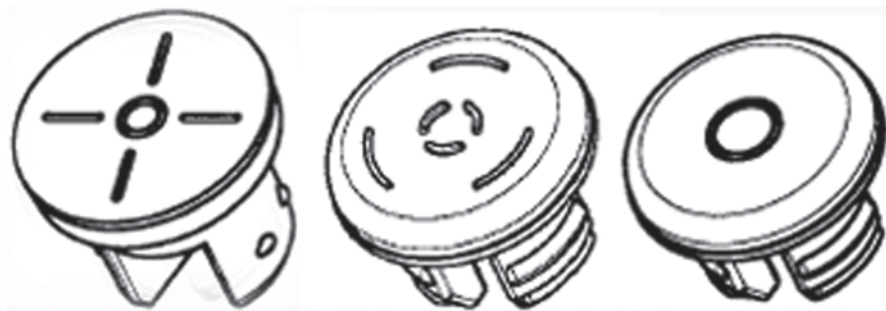
**Fig. 2** Lyo stoppers with one, two, and three vent openings, and with different flange markings

The functionality of flange markings (see Fig. 2) for all elastomeric closures can be described in terms of prevention of stopper clumping during storage, steam sterilization, and machining. This functionality is also valid for lyophilization closures; however, there is an additional functionality that is related to the final stoppering of the vials inside the lyophilization chamber at the end of the freeze-drying cycle. As explained above, the stoppers are pressed down by the shelf that is located above them. During this stage, a significant pressure is exerted on the stopper at the time it hits the vial neck. The pressure is transferred to the stopper flange that is in contact with the underside of the shelf, in other words, the stoppers are firmly pressed with the top of their flanges against a stainless steel plate that for reasons of good cleanability has only a low degree of surface roughness. These conditions are ideal to make the stoppers stick to the underside of the shelf. After pressing the stoppers down, the shelves are separated again. At this stage, it is absolutely undesired that the stoppers keep sticking to the shelf. If they do, then the shelf may pull the stopper slightly out of its seated position and thereby impair the integrity of the seal that at that time and until capping is between the plug of the stopper and the inner diameter of the vial neck. If the stopper is firmly stuck to the shelf and at the same time makes a good fit with the vial, then it may also come to the situation that the entire vial at first is lifted, and then, under the influence of gravity, falls down
